Informational Bulletin

ENHANCED VAPOR RECOVERY

Minimizing Wintertime In-Station Diagnostic System Overpressure Alarms

December 4, 2017

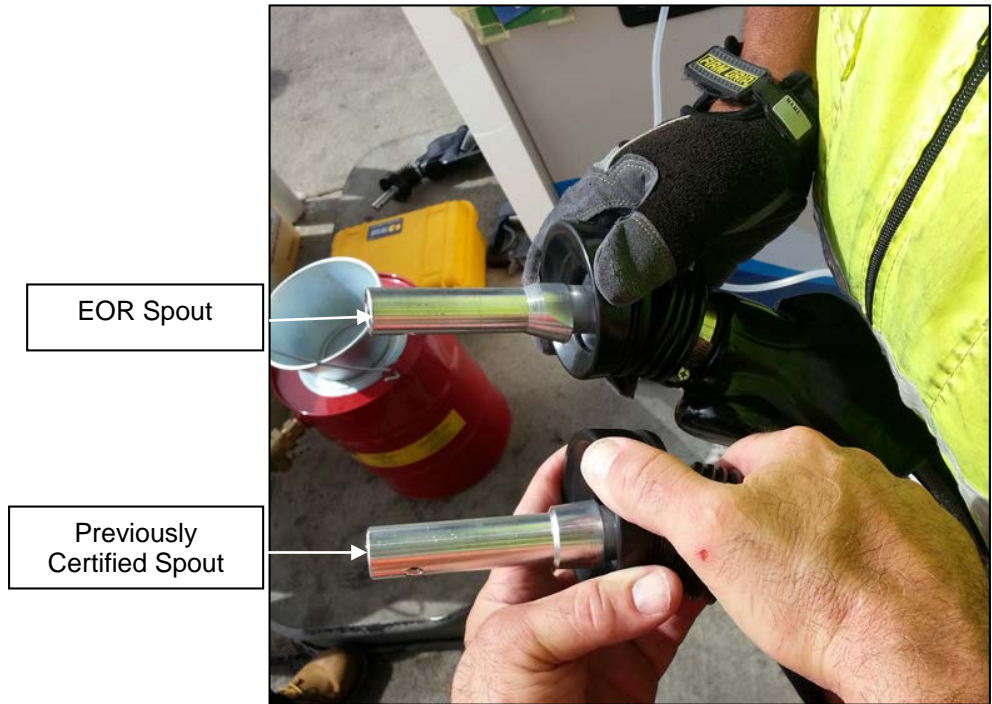
Figure 1: EOR and Previously Certified Spout Assembly (horizontal view)

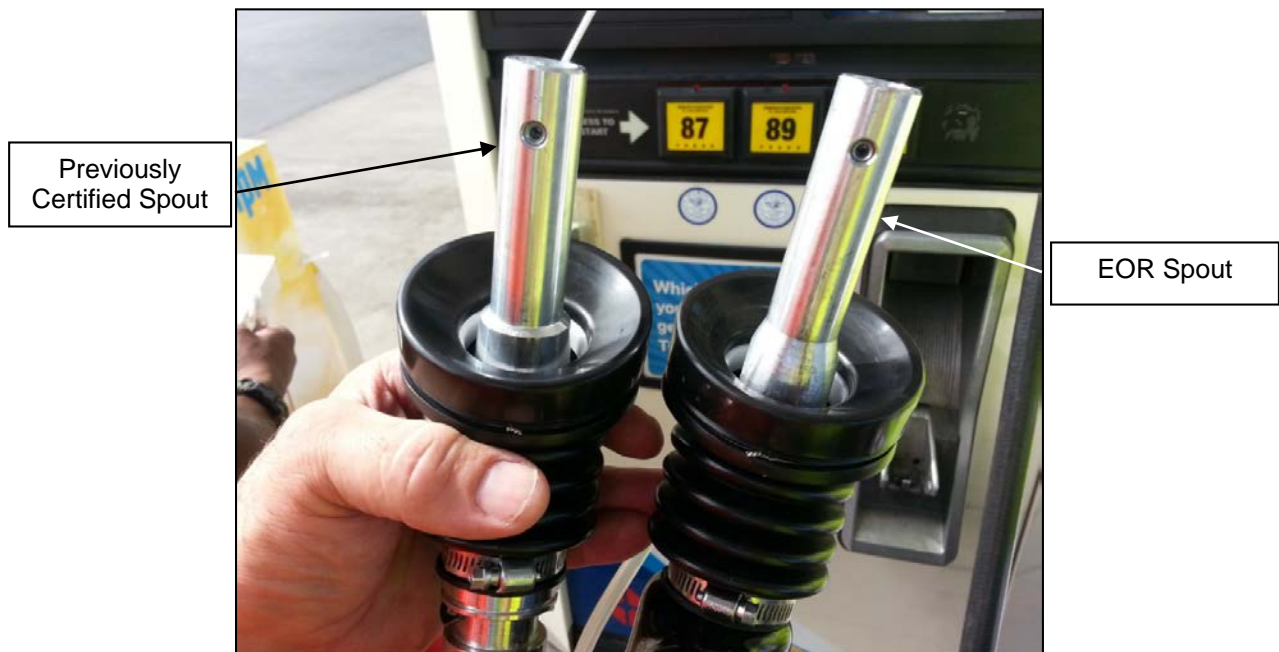
Figure 2: EOR and Previously Certified Spout Assembly (vertical view)
